An IFI Research Report

IFI RR-3

Influence of Phosphorus on Fastener Integrity

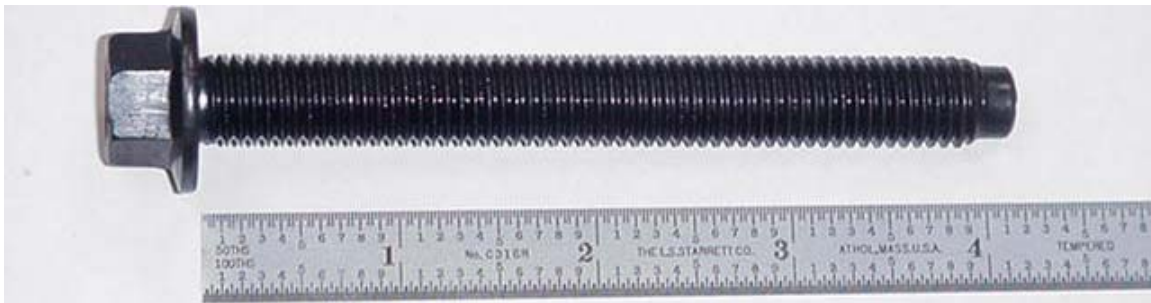
Figure 1

An M12 X 1.75 X 100 mm hex flange screw (Figure 1) was selected for this study with all samples being manufactured by the Shamrock Fastener Division of Textron Fastening Systems. In order to achieve uniformity of product, the screws were manufactured in successive forming operations using the same cold heading machine, thread roller, and tooling.

An M12 X 1.75 X 100 mm hex flange screw (Figure 1) was selected for this study with all samples being manufactured by the Shamrock Fastener Division of Textron Fastening Systems. In order to achieve uniformity of product, the screws were manufactured in successive forming operations using the same cold heading machine, thread roller, and tooling.

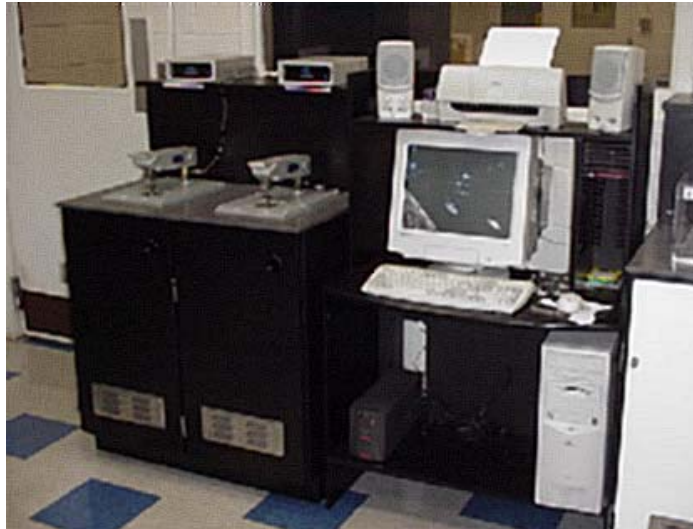
Photo 1 - RSL™ Test System

Photo 1 - RSL™ Test System

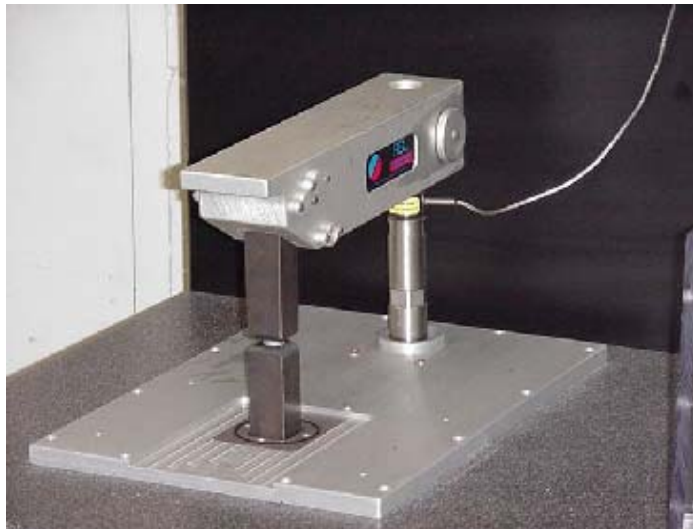
Photo 2 - RSL™ test in air

Photo 2 - RSL™ test in air
